BULLETIN PA003-13

Water Pump –
44033

Cadillac

PERCEIVED WATER PUMP LEAK

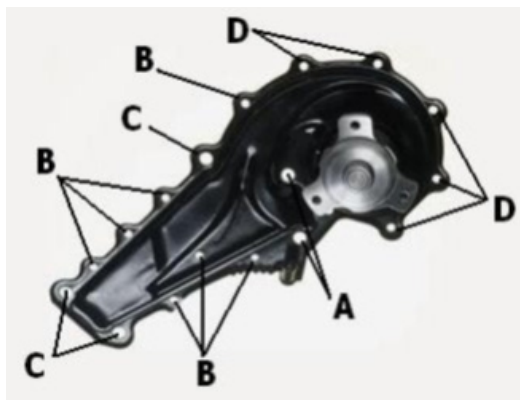
NAPA Tru-Flow Water Pump Engineers have identified an issue concerning possible coolant leakage around the water pump. If coolant leakage should occur be sure to inspect the mating surfaces on the water pump and the timing cover. After thorough analysis of this water pump, NAPA Tru-Flow has determined that a common cause of leakage is a bent or uneven surface between the water pump and timing cover. A damaged sealing surface will allow a path for coolant to leak out.

In addition, extra care must be taken when removing the water pump. Only the water pump mounting bolts should be removed; none of the bolts associated with the timing cover should be removed. The loosening of any timing cover bolts may cause the pump gasket to shift, thus causing a leak. This leak will be incorrectly perceived as a water pump failure. A thorough inspection of the mating surfaces should be performed prior to pump installation. Both mating surfaces should be flat as well as clean and free of debris. When installing the bolts, alternate from one side to the other, working in a clockwise direction. **It is imperative that the proper torque sequence and specifications be followed!**

Torque [Ft. Lbs.]	Torque [N.m]
A	30	41
B	5	7
C	30	41
D	5	7
