**BULLETIN PA005-13****PART NUMBER:**41185
43541**MAKE:**

FAN CLUTCH INSTALLATION

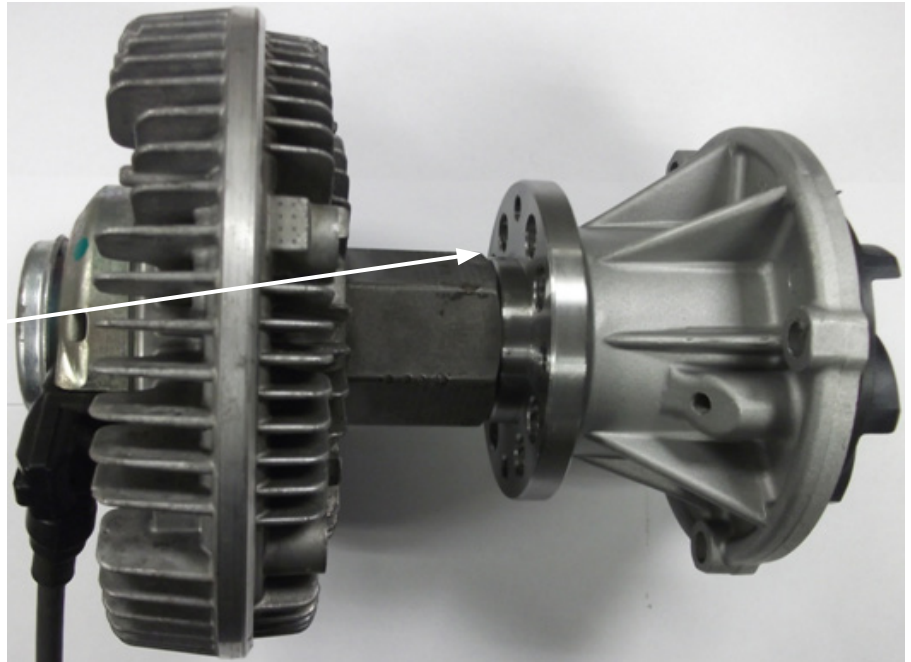
Fan clutch and water pump need to be seated & torqued to 98 Ft. Lbs/133 N.m before engine is started.

NOTE: OE Recommended Torque Specification Is: (98 Ft. Lbs. or 133 N.m). The clutch nut is manufactured with right handed threads and will need to be rotated **"COUNTERCLOCKWISE"** for removal.

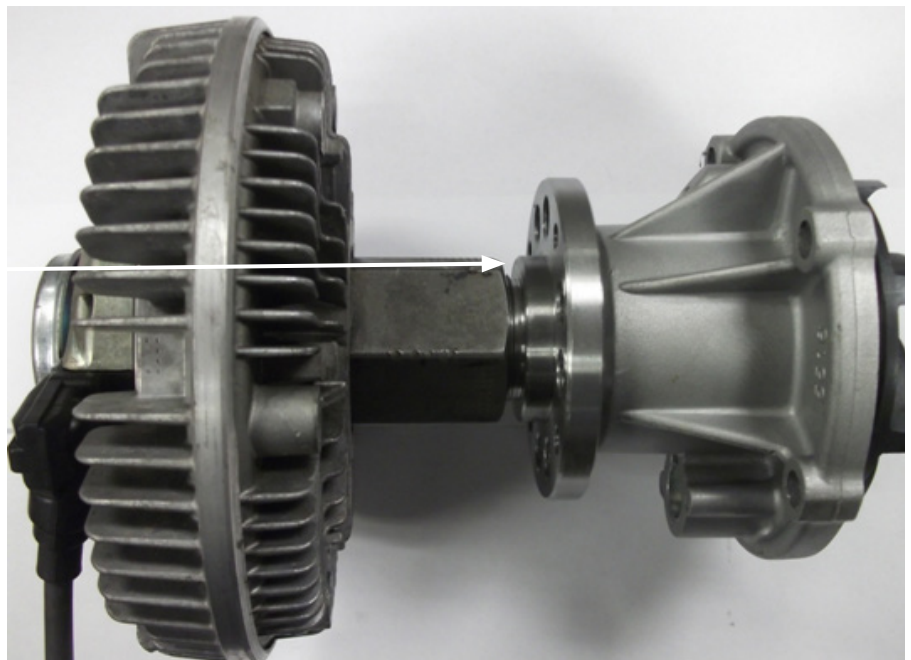
A loose fan clutch assembly will create an imbalance within the fan to water pump. This imbalance creates excessive force upon the water pump shaft and bearing which can lead to a bearing walk out condition. This premature failure due to improper installation may affect other nearby components resulting in excessive repair costs.

Improper installation between fan clutch and water pump.

Upon installation of the fan clutch assembly, be certain to completely secure the clutch nut until flush with the water pump flange. Failure to secure and **"PROPERLY TORQUE"** the fan and clutch assembly to the water pump, may lead to premature water pump failure and or an unsafe operating condition.
