**BULLETIN PA010-12**

**PART NUMBER:**  
 38332

**MODEL:**  
 Accord  
 Odyssey  
 Pilot  
 Ridgeline

**ACCESSORY BELT DRIVE SYSTEM  
 HONDA**

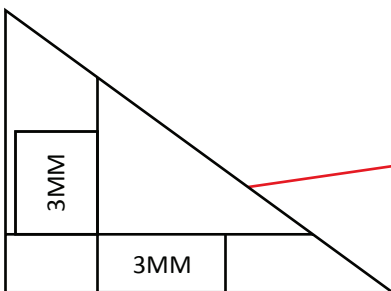
This area will need to have 3mm of material removed.

Particular V-6 applications described in Honda Bulletin 08-082 may require a small modification to the front timing cover during replacement of the accessory drive belt tensioner. (NAPA part number 38332 ) The OE now provides an updated tensioner assembly which may cause interference with the front timing cover of some applications. NAPA Belts/Hoses also offers the same, updated design as the OES. The small task is to remove approximately 3mm of plastic material from the front cover, allowing proper clearance.

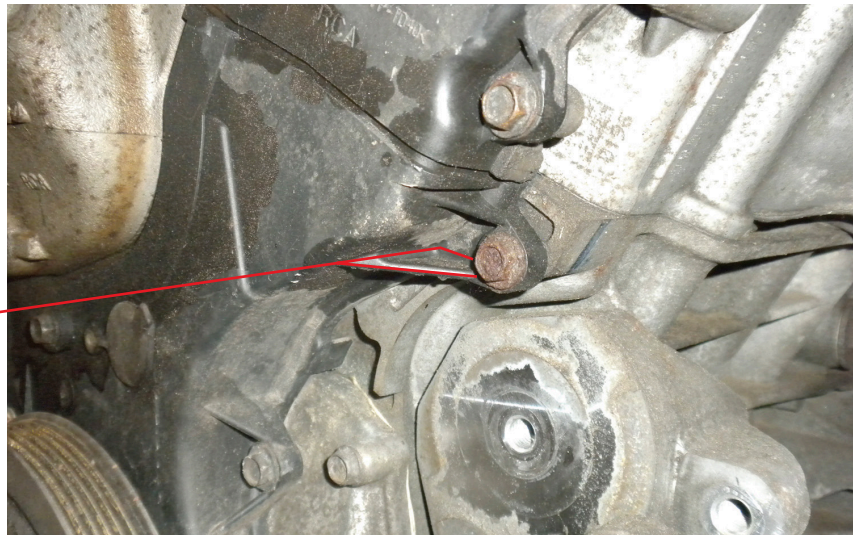
**IMPROPER INSTALLATION MAY RESULT IN A DAMAGED FRONT TIMING BELT COVER AND IMPROPER ACCESSORY BELT TRACKING, EVENTUALLY LEADING TO BELT FAILURE!**
