NAPA Micro-V[®] Belts: Belt Wear Alert

AN IMPORTANT MESSAGE
FROM NAPA BELTS/HOSE

EPDM WEAR INDICATORS AND SYMPTOMS

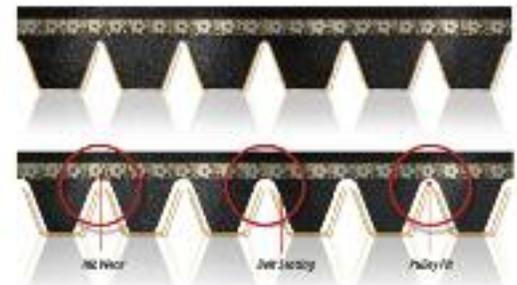
Belt wear after 100,000 miles

The diagram on the right shows a new belt profile (top), and a worn belt (bottom)—with indicators to show the original profile. Material has been lost on both the side and top surfaces of the ribs, making the space between ribs wider. As more material is lost, the pulleys ride deeper into the belt grooves.

- Over time, belt ribs lose material
- With material loss the space between the ribs increases
- The belt can “bottom out” on the pulley
- This causes accelerated wear, belt slip, and contamination
- When water cannot channel out between the belt and pulley, hydroplaning (like a tire on a wet road) can result

With sufficient material loss, the pulley ribs “bottom out” in the grooves and ride on the belt undercord. This reduces the surface contact on the v-rib sides, where the traction is generated. It also increases the effective belt length, lowering the tension in the system, which also reduces traction.

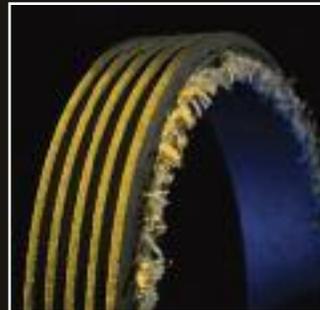
Visual signs of belt wear

Abrasion/Misalignment

If the belt exhibits one or more of these symptoms (right), it needs to be replaced. If it fails, it could damage other system components in addition to stranding the motorist. Many warranty-claim failures on alternators and other parts are actually caused by worn or improperly adjusted belts. Warranty claims are bad for business—and customer satisfaction.

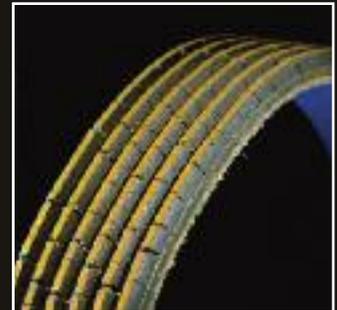
Cracking

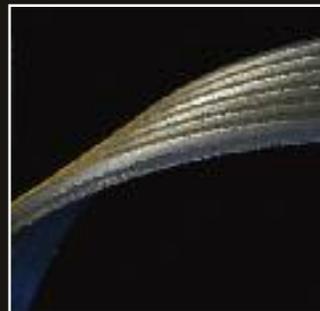
Glazing

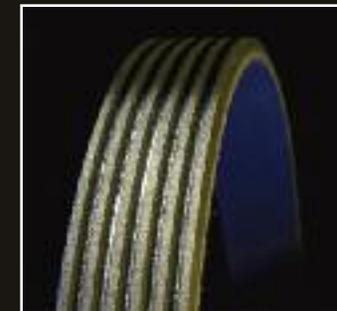
Pilling

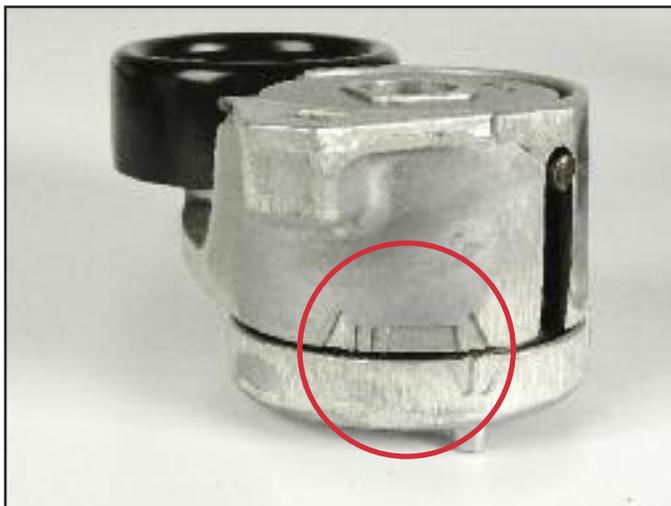
Look for the Tensioner Belt Wear Indicator found on many Automatic Belt Tensioners

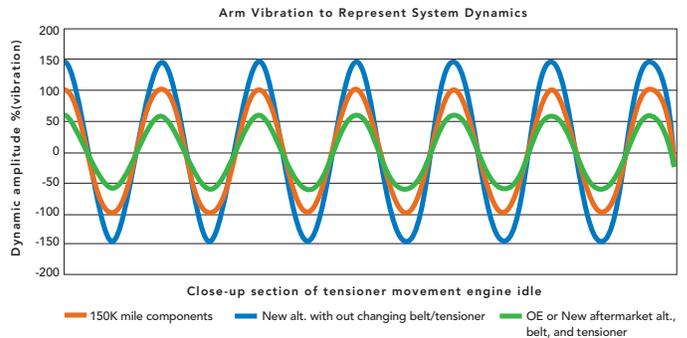
Accessory Drive Vibration with New/Worn Parts

- Arm vibration is minimized with a new, alternator, belt, and tensioner ■
- After 150,000 miles the worn alternator, belt, and tensioner cause increased vibration ■
- When replacing an alternator without replacing the belt and tensioner, arm vibration is increased as the worn belt and tensioner do not dampen the new component effectively. ■
- Excessive arm vibration results in belt noise and bearing wear to accessory drive components.
