## NAPA Belts/Hose BRANCHED HOSE SOLUTION

NAPA Belts/Hose released two new hoses to address a common failure on **2008-09 Chrysler Town & Country and Dodge Caravan minivans**. The branching component (or "Y" connector) are prone to cracks, which can result in premature failures. Our research indicates that demand for these replacement hoses thru dealers **exceeds 1,100 units per week**.

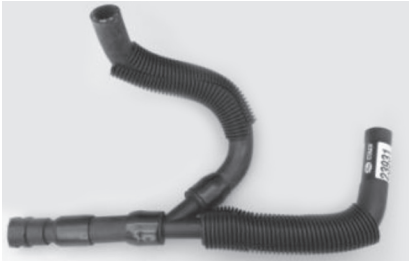
#16598

NAPA Belts/Hose engineers designed Part No. 16598 and Part No. 16599 with the following improvements to the hose branching component, providing a more robust branched hose assembly:

1. Developed the "Y" connector using high temperature and hydrolysis resistant materials with a 35% glass fill. This provides a stronger, longer lasting component.
2. PowerGrip SB clamps are used to connect the hoses for leak free joints and eliminate the potential of damaging the components with excessive pressure.

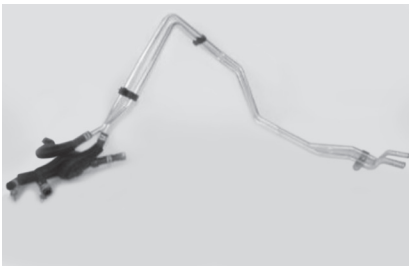
OE Hose Assembly

NOTE: The OE dealer only offers the entire assembly, including the rear heater pipe. The heater pipe does not fail and including this in the assembly creates a more difficult repair. No cutting of crimps required. Old hose can easily be removed by releasing the constant tension clamp and replace with the NAPA Belts/Hose assembly.
