**BULLETIN PA003-11****PART NUMBER:**

ENGINE:3.3L
3.8L**SOLUTION KIT 38379K - CHRYSLER CORP.**

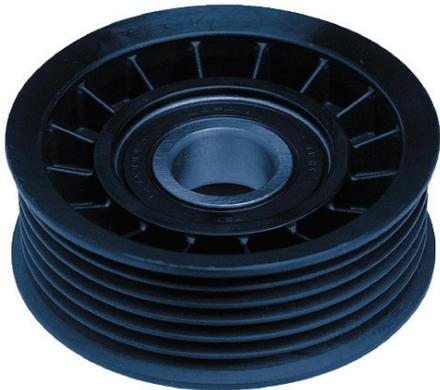
38009 = 76mm O.C. Provided in kit

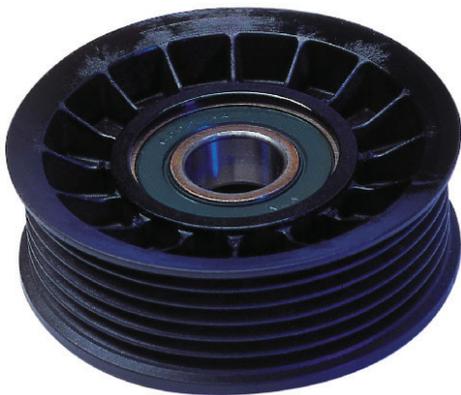
38008 = 70mm O.C. Use if belt length issues are encountered due to other aftermarket accessory replacement components.

Always check that the tensioner is in the proper operating range after repairs.

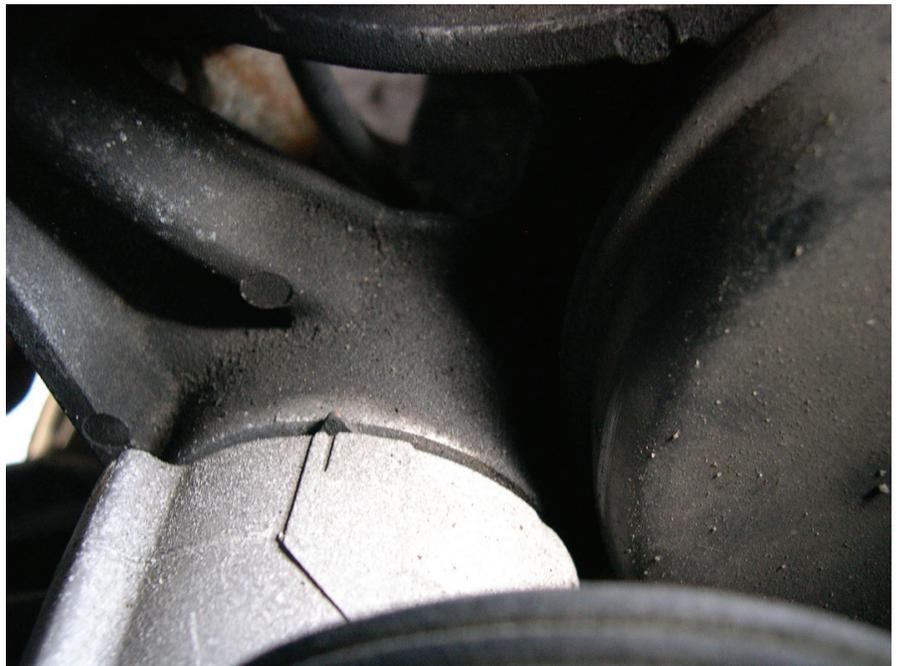
** The NAPA Belts/Hoses Dual Sided Micro-V Belt provided in the kit is designed to operate on the smooth pulley attached to the water pump.
