## SYNCHRONOUS BELT DRIVE SYSTEM TECHNICAL SERVICE BULLETIN

### BULLETIN PA007-11

Timing Kit - 2523120  
Timing Kit W/Pump - WPK41115  
Timing Belt - 250312

### INSTALLATION RECOMMENDATIONS FOR TIMING BELT SYSTEM ON HONDA 1.7L ENGINES

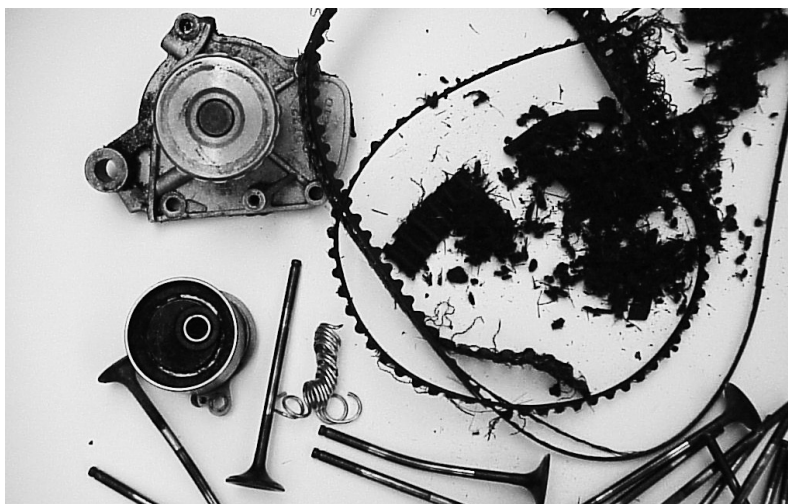
Below is the result from improper belt setup. Notice the damaged spring, this is the result of turning the crankshaft clockwise during initial setup, which is incorrect.

See installation instructions provided in this kit. Crankshaft must be rotated two turns **COUNTERCLOCKWISE** with locking pin in tensioner and attachment bolt loose.

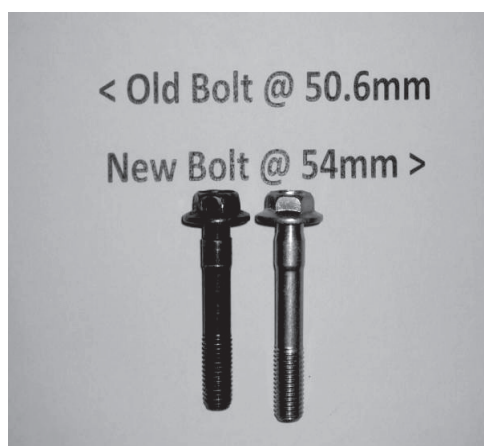
### 2001 – 2003 model years may require a longer fastening bolt!

Please be advised that early model year Civics may require an updated tensioner bolt. Honda upgraded the timing belt tensioner assembly in late 2002. NAPA Belts/Hoses T43175 follows the design change. During this change the OE bolt length was also changed to allow for proper thread engagement. NAPA Belts/Hoses supplies the updated bolt as part of 2523120/WPK41115 kits.

Verify this issue with one of the following procedures, the updated OE tensioner and bolt has been provided in this kit.

1. With tensioner fastening bolt placed through tensioner assembly – Verify there is 15mm of thread engagement.
2. Measure Bolt: Bolt length for new tensioner design provided in this kit should be 54mm in length.  
(Incorrect Bolt Length Is 50.6mm)
